Auto-Max™

Autogeneous
Bone Harvester

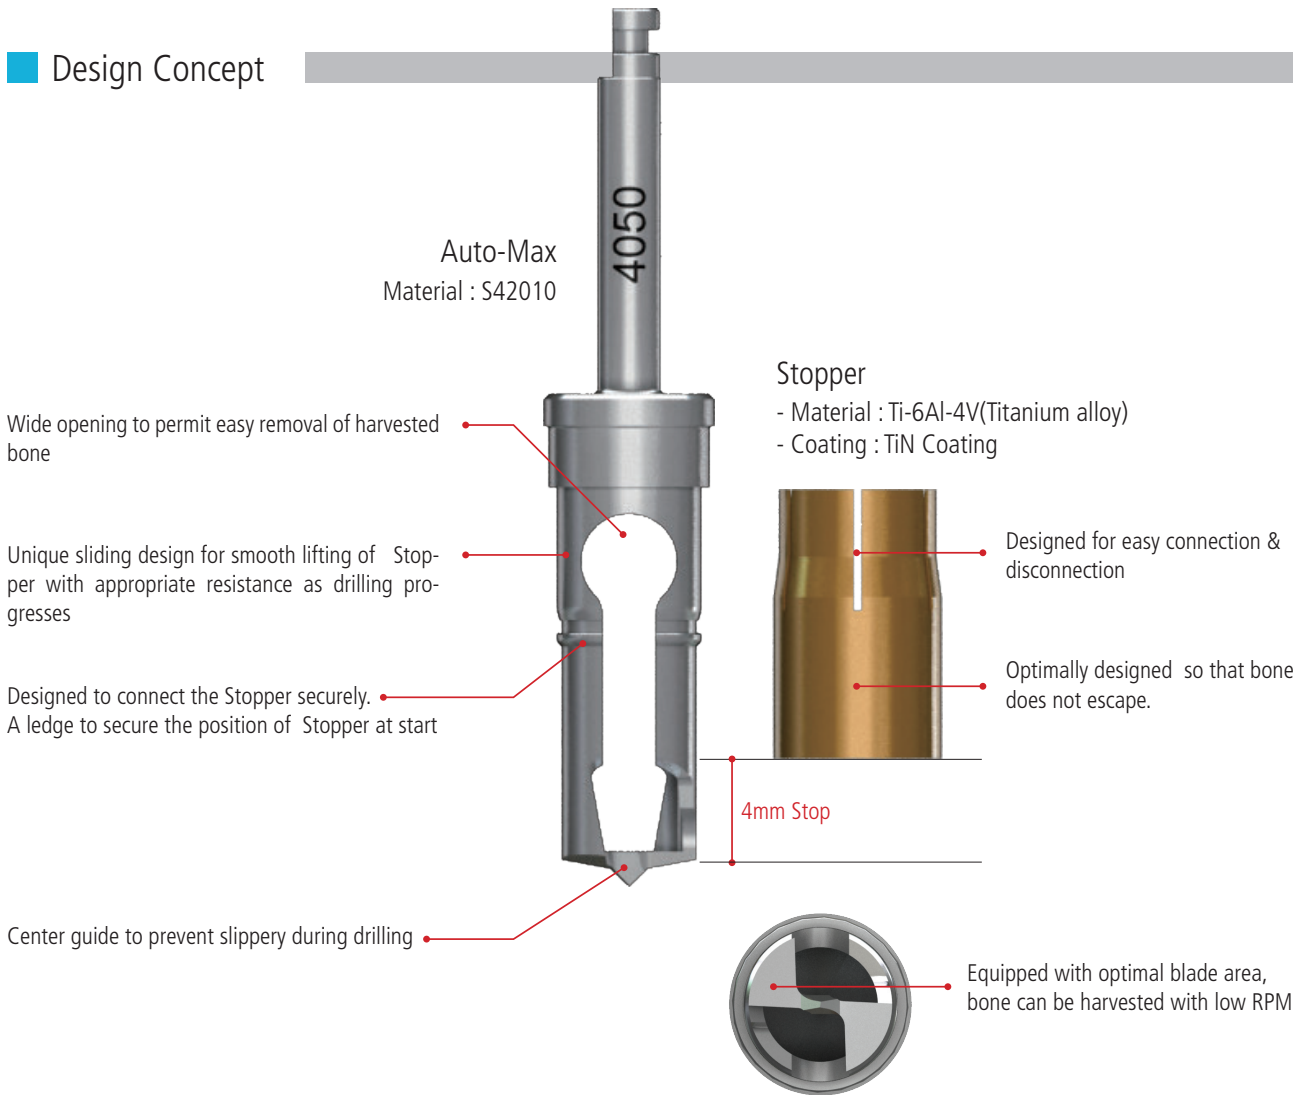
■ Design Concept

Easy and Fast Insertion

- 1) Sufficient cutting force can be obtained even at low RPM.
Autogenous bone can be harvested within 10 seconds!
- 2) Amount of bone harvested may be equivalent to the size of Auto-Max!
- 3) Enables quick, easy bone harvesting in a single procedure!
- 4) It can be cleaned thoroughly as the Stopper is easily disconnectable!
- 5) V shaped opening completely prevents bone chips from splattering during drilling!
- 6) May be used in any type of bone with excellent durability!

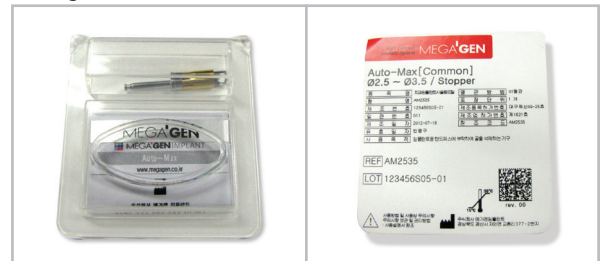
Package

| Ref. Code | Diameter(Ø) | Ref. Code | Diameter(Ø) |
| AM2535 | Ø3.5 | AM5060 | Ø6.0 |
| AM4050 | Ø5.0 | AM6070 | Ø7.0 |
